HOMC APPLICATION NOTE-2

Corrosion Assessment at Trunnion Supports

HOMC INSPECTION of 14inch Hydrocarbon Line

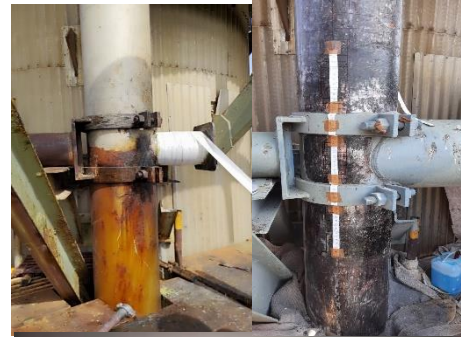
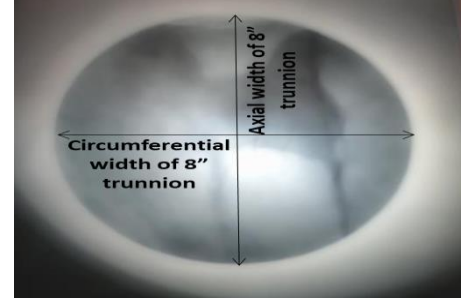
A 14inch Pipe in service at a leading refinery failed at the Trunnion Support. Initial Radiography carried out showed crack like indication but due to pipe size and access restrictions did not yield clear results of the wall loss or depict profile. The client in the meanwhile arrested the failure and welded another pipe over the leaking trunnion.

Axial HOMC (AHOMC) in the through transmission TT Mode was conducted post leak mitigation and the profile of the corrosion in the trunnion region was identified. The X-ray image of cracks were the rupture points in the deepest section of wall loss estimated to be > 80%. Average wall loss was 65-75% based on the measured wall thickness of 9.5-10mm.
