HOMC APPLICATION NOTE-6

Corrosion Assessment Under Pipe Bundwall (<1m)

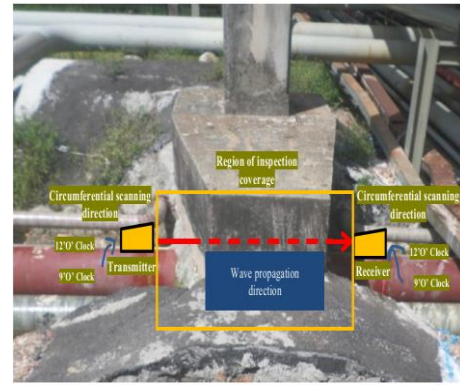
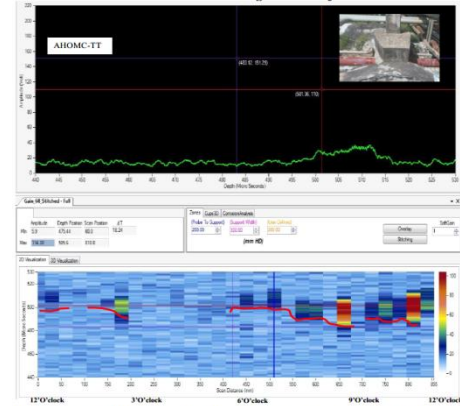
HOMC INSPECTION of 12 inch AGO Pipe Passing Through Concrete

A 12inch AGO Line crossing under a concrete Bunwall was inspected in a Refinery using AHOMC-TT Method. The length of the bund wall was \approx 1 to 1.1m. Corrosion with an estimated wall loss of about 55-65% was observed on the pipe section covered under the concrete. The corrosion was present around the 6 'O' clock position of the pipe. End customer hacked the concrete portion at around the 6'O' clock position to validate the HOMC findings. A localized patch of corrosion was observed at 6'O' clock position and a maximum depth of 60% wall loss was observed.

The defects were mapped very accurately by HOMC and sizing levels were extremely precise when compared with pit gauge measurements. The advantage of HOMC is that it is not affected by the wrapping and through transmission technique deployed are amplitude independent to provide accurate defect profile and sizing.

The deepest corrosion profile between the two probes seen across the pipe circumference is as highlighted in red. In some locations loss/scattering of data was seen possibly due to the attenuation caused by the concrete cover (very tight bonding between the pipe and concrete can sometimes cause attenuation due to signal leakage). The wall loss estimation is strictly based on the regions from where reliable data was obtained and there is a possibility of some potential deeper spots.

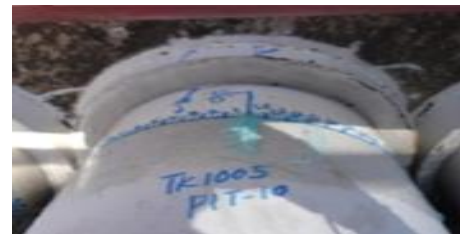
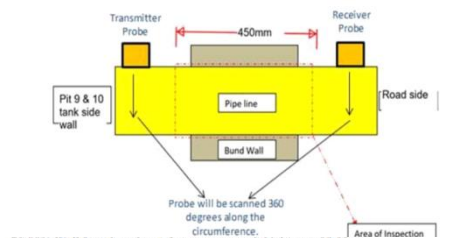
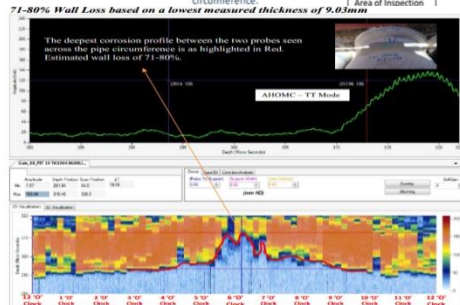
HOMC INSPECTION of 20 inch Pipe Passing Through Bund wall

A major tank terminal facility was experiencing leaks in there pipes that was passing through the Bunwall. The length of the Bundwall was \approx 450-500mm. The end customer called for a HOMC inspection in order to detect and quantify the deepest corrosion spot on the pipe covered under the Bund wall.

The inspection was performed by Axial -TT HOMC. Corrosion in most of the pipes were observed between 5 'O' clock to 7'O' position as per the HOMC data. In some locations there was a small gap between the bund wall sleeve and the pipe, the end customer did some visual inspection using boroscopy to confirm the presence of defects and get a rough estimate of the depths. The visual findings co-related well with the HOMC findings.
