HOMC APPLICATION NOTE-2

Corrosion Assessment at Trunnion Supports

HOMC INSPECTION of 14inch Hydrocarbon Line

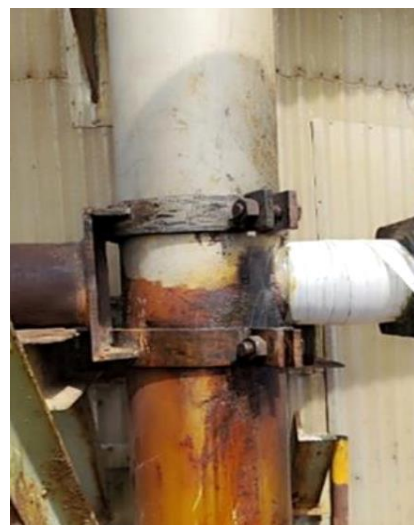
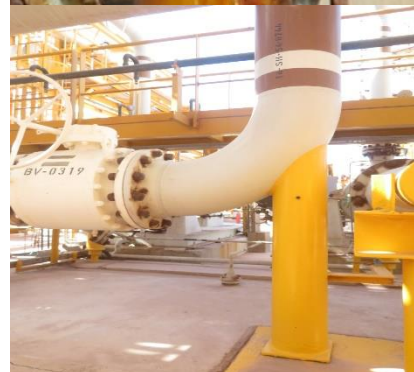
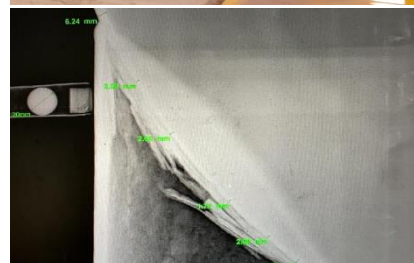
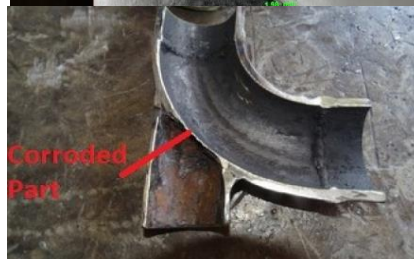
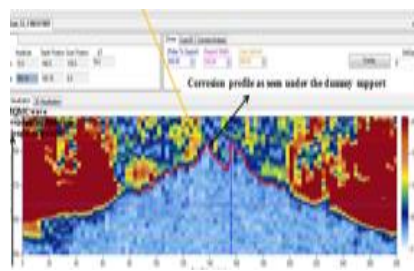
A 14inch Pipe in service at a leading refinery failed at the Trunnion Support. Initial Radiography carried out showed crack like indication but due to pipe size and access restrictions did not yield clear results of the wall loss or depict profile. The client in the meanwhile arrested the failure and welded another pipe over the leaking trunnion.

Axial HOMC (AHOMC) in the through transmission TT Mode was conducted post leak mitigation and the profile of the corrosion in the trunnion region was identified. The X-ray image of cracks were the rupture points in the deepest section of wall loss estimated to be > 80%. Average wall loss was 65-75% based on the measured wall thickness of 9.5-10mm.
