TANK SHELL PLATE CORROSION INSPECTION

ESCON DHVANI
HIDDEN CORROSION INSPECTORS

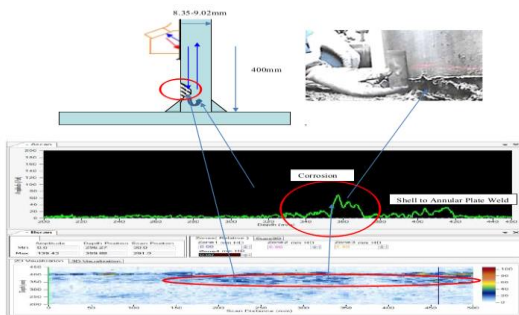
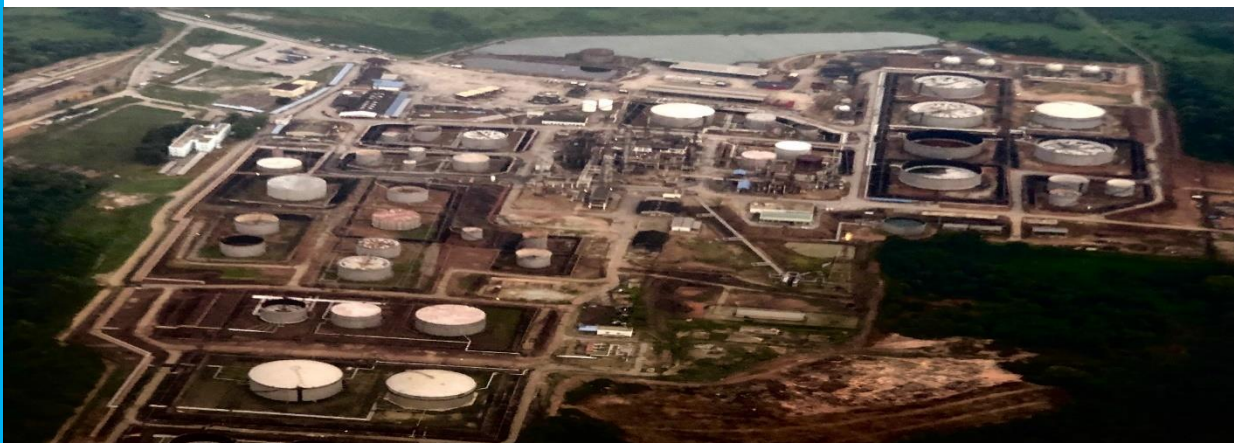
A new concept for the improved inspection of corrosion at annular plate in the near shell wall region of storage tanks using a short-range ultrasonic guided wave technique that uses a collection of Higher Order Modes Clusters, called here as **HOMC*** has been developed and verified at several field sites. Ultrasonic guided waves, once generated will be reflected from corrosion in the plate. Inspection can be carried out from outside the tank mounting the probes on the Shell plate and looking towards the region of interest on the accessible portion of the Shell plate. Presence of welds, uneven surfaces or coatings does not come in the way of inspection using HOMC technique. Reflections from corrosion are assessed and wall loss is estimated.
